## Instructions for visiting the *SS Thistlegorm* wreck

### Preservation Guidelines:

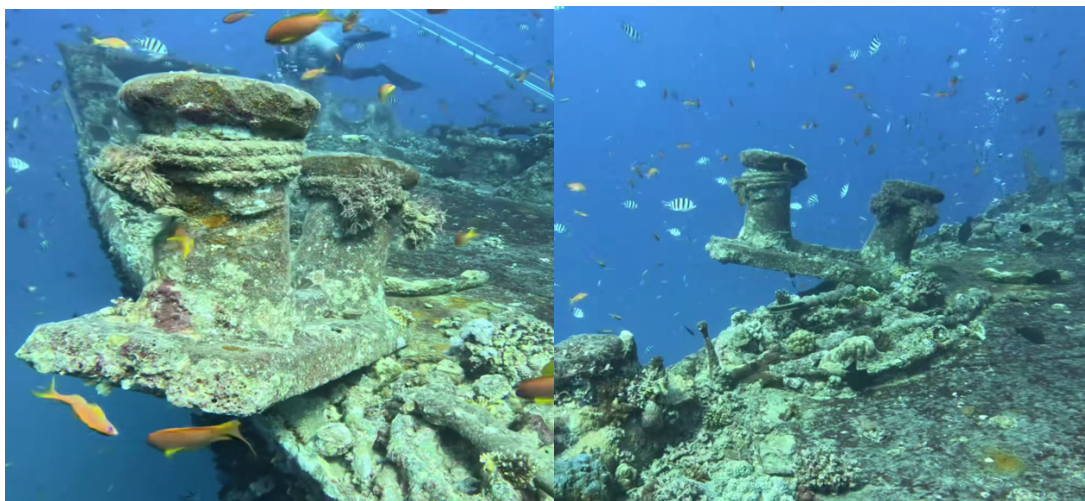
## Double mooring bollards on the left side of the wreck:

The double mooring bollards have been broken and are about to separate completely from the body of the wreck, attaching the ropes to this area is completely forbidden.

1. **Avoid using metal wires for mooring:** Metal wires can cause erosion and damage to the wreck's hull.
2. **Mooring to weak or unstable parts of the hull is prohibited:** Attach ropes only to strong and stable parts of the hull. (kindly find below illustrations on where to attach the ropes).
3. **Divers with less than 20 dives or buoyancy issues are not permitted to visit the wreck.**
4. **Touching the wreck is strictly forbidden:** Do not sit, touch, or kick the wreck with your fins.

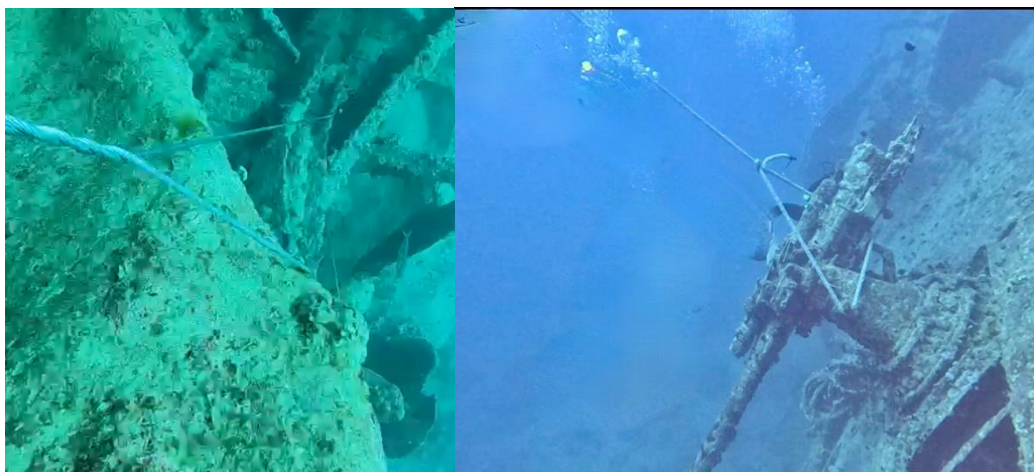
## Examples of bad and irresponsible practices:

Using metal wires and attaching the rope to the ship cannon.

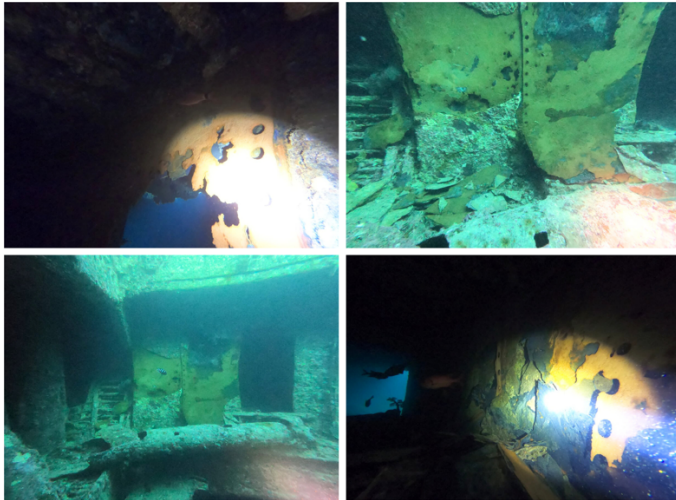
## Recent damage to the *SS Thistlegorm*.

In recent years, the *SS Thistlegorm* has suffered damage due to irresponsible practices. Some parts of the wreck have been damaged and others are at the risk of breaking off the hull entirely.
